Your Inspection Report

123 ABC Ln Winston
Salem, NC 27127

Thursday, October 29, 2020

RE: Report No. 1008
123 ABC Ln Winston Salem, NC
27127

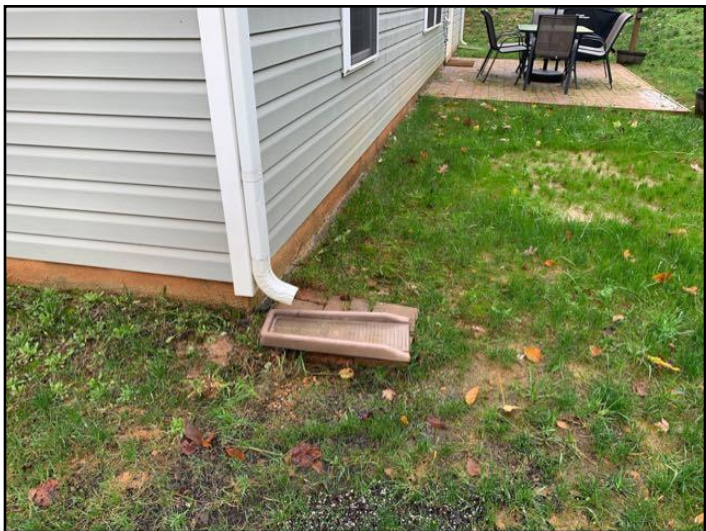
Condition: • [Discharge too close to building](#)

Implication(s): Chance of water damage to structure, finishes and contents

Location: Rear exterior

Discharge too close to building

Task: Repair

Time: As soon as possible

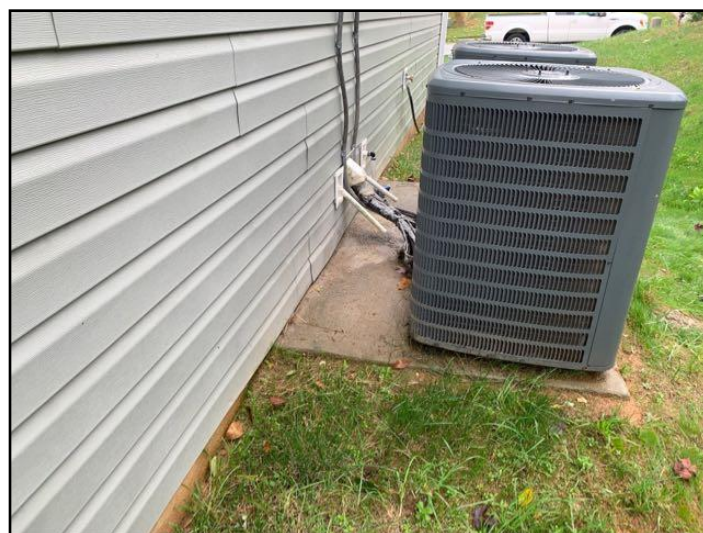
Condition: • [Too close to grade](#)

Implication(s): Chance of water damage to structure, finishes and contents

Location: Left Side Exterior

Too close to grade

Task: Repair

Time: As soon as practical

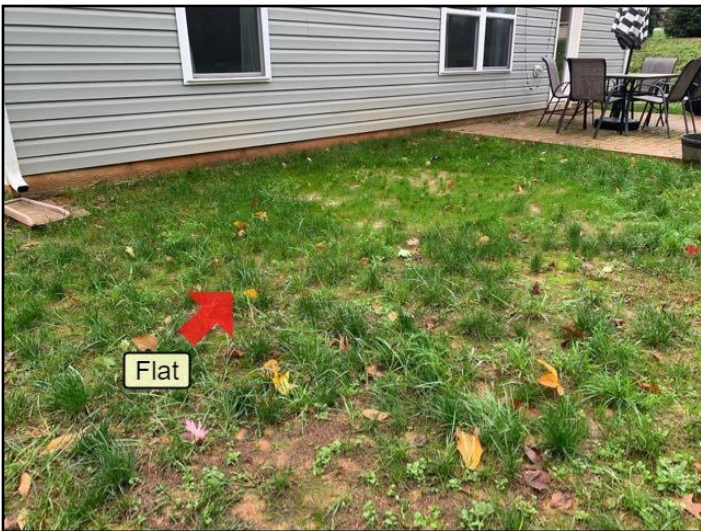
Condition: • [Improper slope or drainage](#)

Implication(s): Chance of water damage to structure, finishes and contents

Location: Various Yard

Improper slope or drainage

Task: Repair

Time: As soon as practical

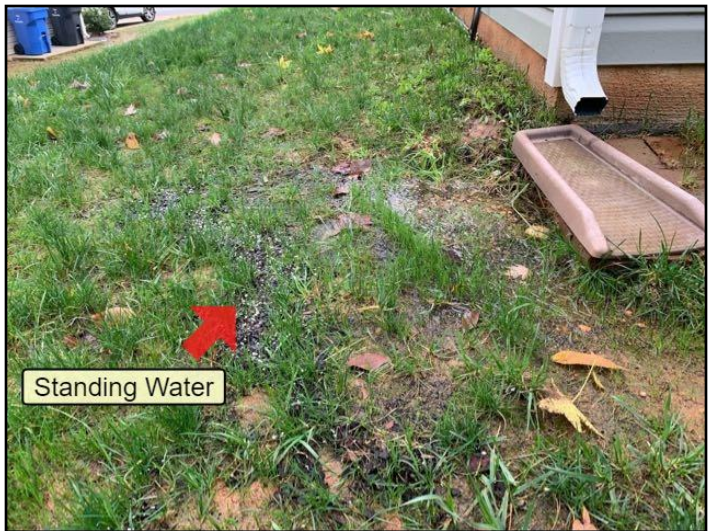
Improper slope or drainage

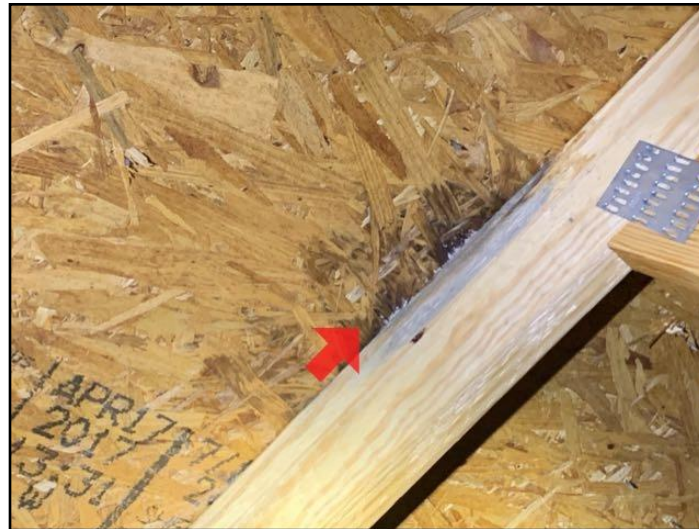
Condition: • Water damage

Implication(s): Chance of water damage to structure, finishes and contents | Weakened structure

Location: Right Side Attic Garage

Water Damage

Task: Repair

Time: Immediate

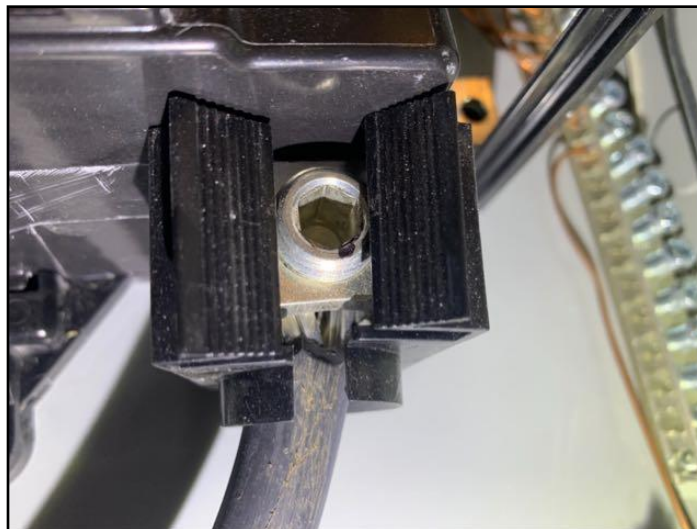
Main Breaker Lug

Condition: • The aluminum strands are separated at the lug and aluminum stranded wires typically have an anti oxidation coating. It is recommended an electrician evaluate and make any repairs necessary.

Implication(s): Possible Overheating

Location: Right Side Garage

Task: Improve

Time: As soon as practical

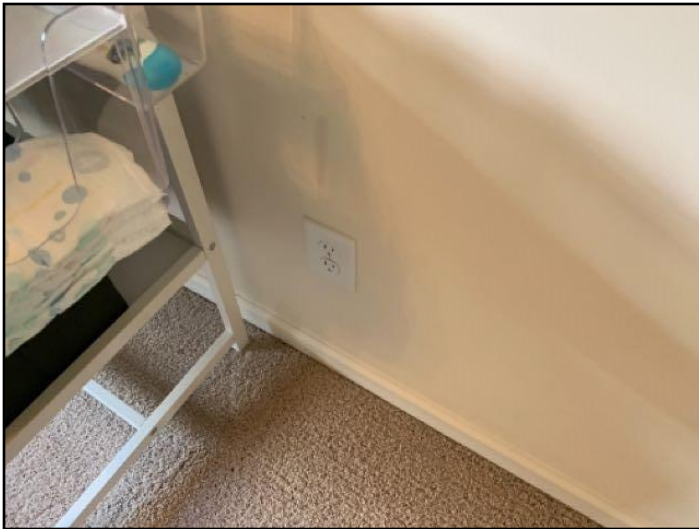
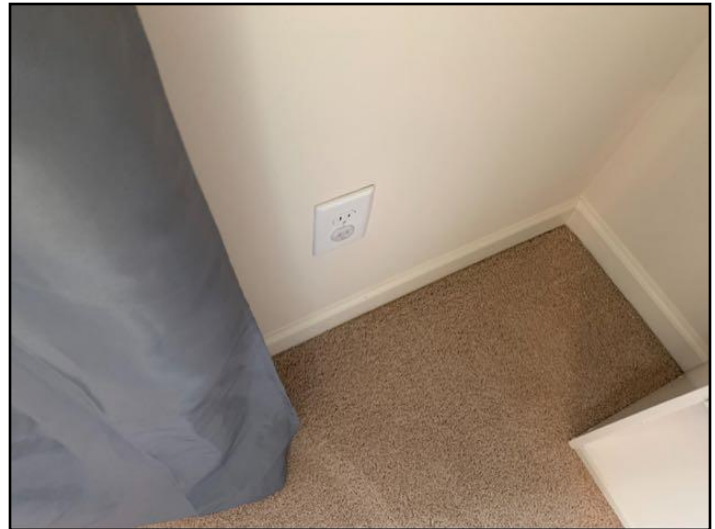
Condition: • [Ungrounded](#)

Implication(s): Electric shock

Location: Various Rear Second Floor Bedroom

Ungrounded

Task: Repair

Time: As soon as possible

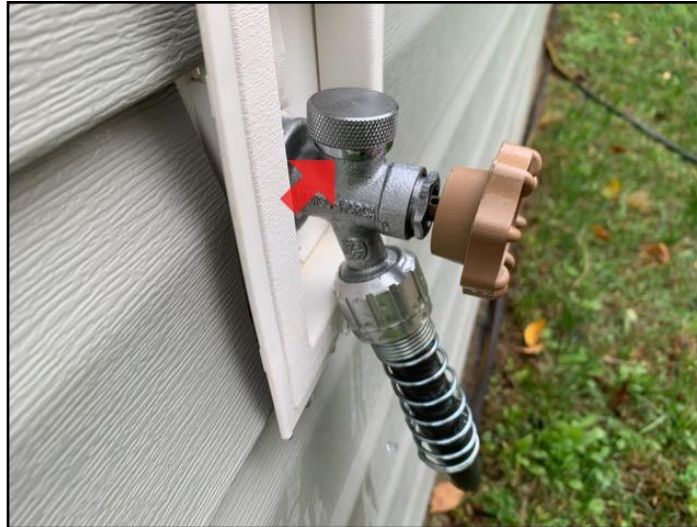
Condition: • Backflow prevention defective

Backflow prevention defective

Task: Repair

Time: As soon as practical

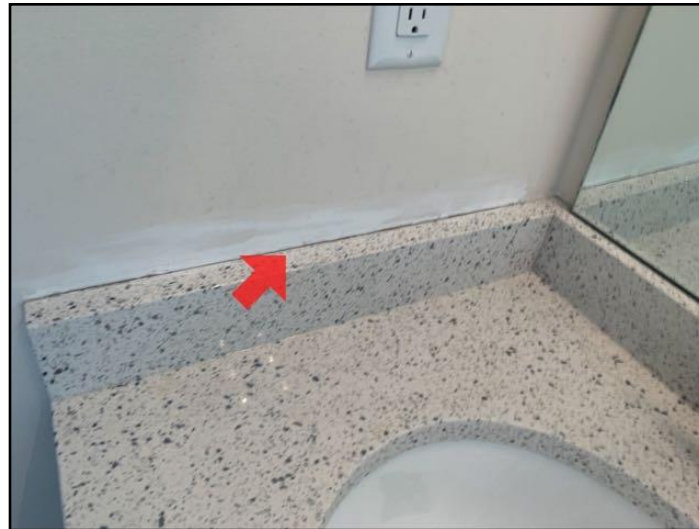
Condition: • Missing Caulk

Implication(s): Damage to finishes

Missing Caulk

Task: Improve

Time: Discretionary
